CORNER RECORD

BK 56 PG 36
 Document Number CR-3414

Brief Legal Description MONUMENT AT THE INTERSECTION OF ACORN & YUMA STREETS.

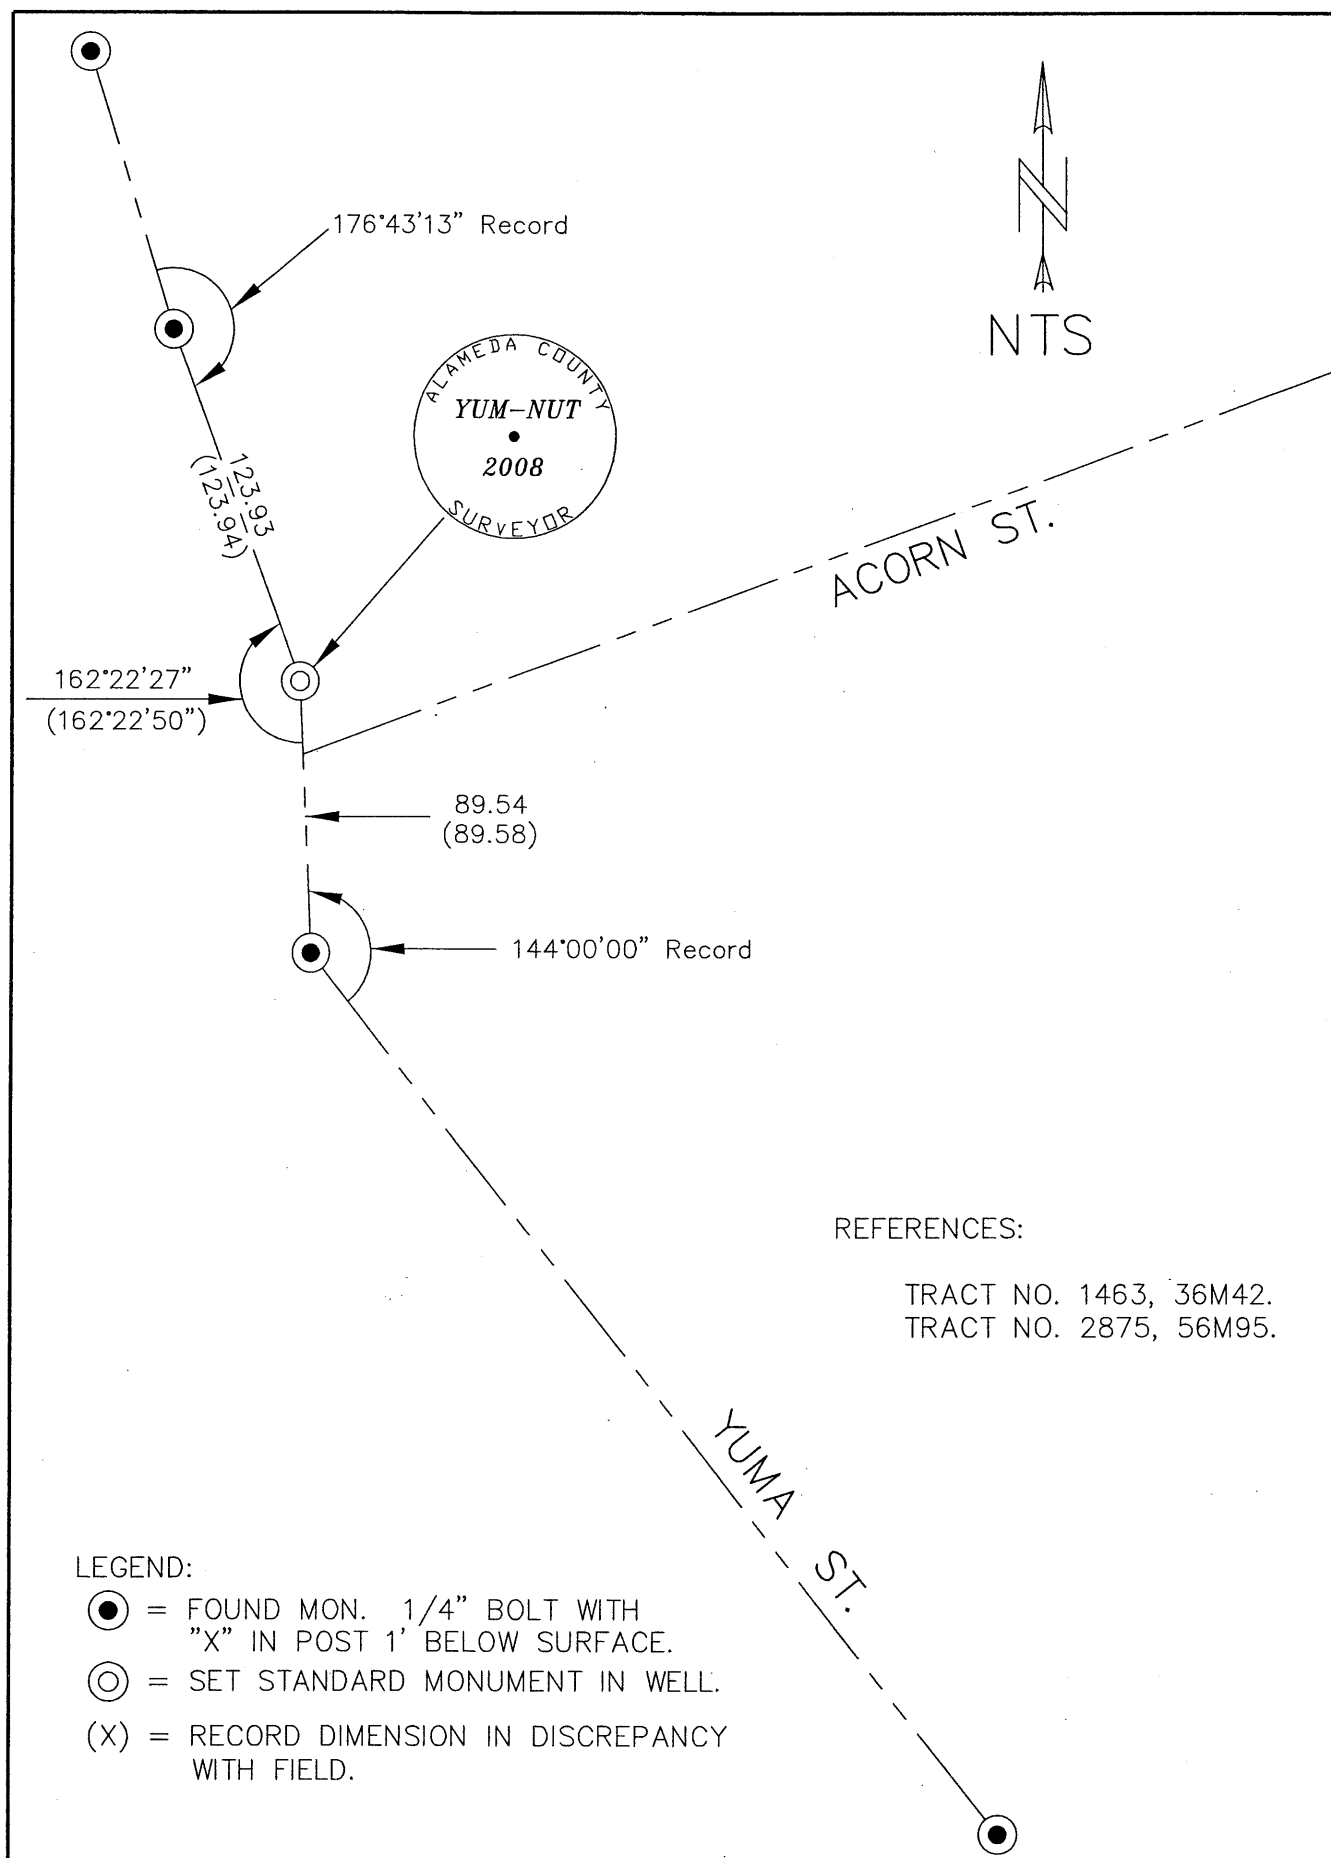
Identification and type of corner found: Evidence used to identify or procedure used to establish or reestablish the corner: THE MONUMENT DESCRIBED BELOW WAS REESTABLISHED BY RECORD INFORMATION ON TRACT MAPS 1463 AND 2857. SEE DRAWING ON NEXT PAGE.

A description of the physical condition of the monument as found and as set or reset: A STANDARD TRACT MONUMENT IN A MONUMENT WELL WAS DESTROYED DUE TO STORM SEWER CONSTRUCTION. THE MONUMENT WAS AT THE INTERSECTION OF ACORN AND YUMA STREETS.
